AFHRL-TR-90-41

INTEGRATED MAINTENANCE INFORMATION SYSTEM
DIAGNOSTIC DEMONSTRATION

August 1990

Final Technical Report for Period August 1987 - April 1990

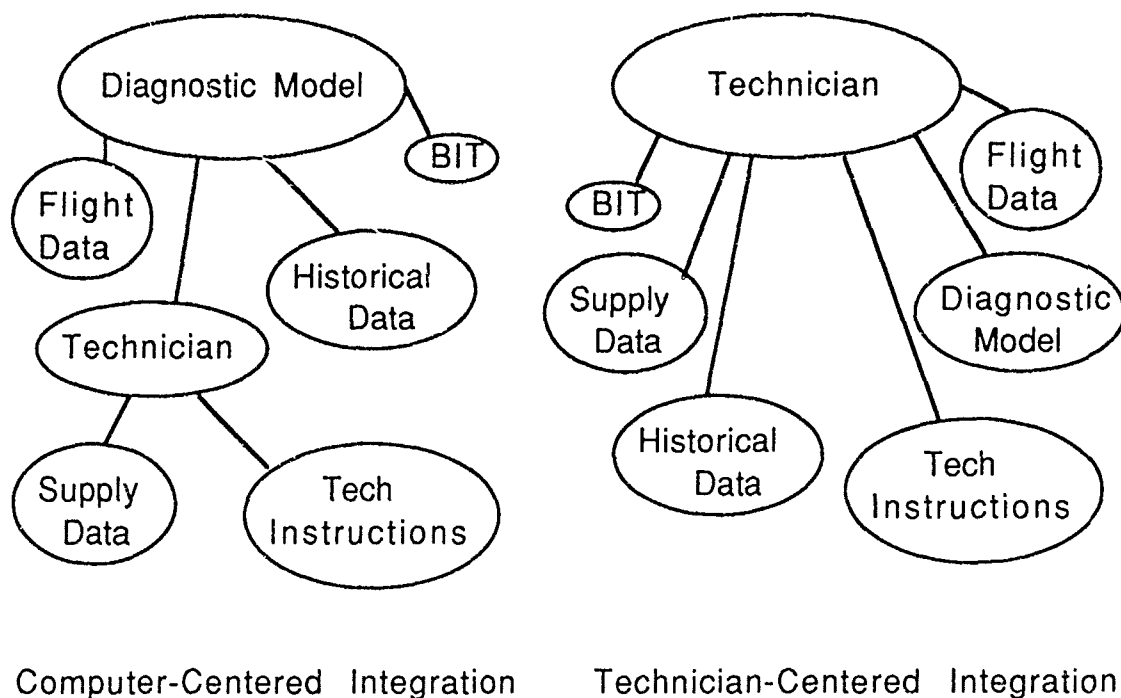
Figure 1. Computer-Centered Integration Versus Technician-Centered Integration.

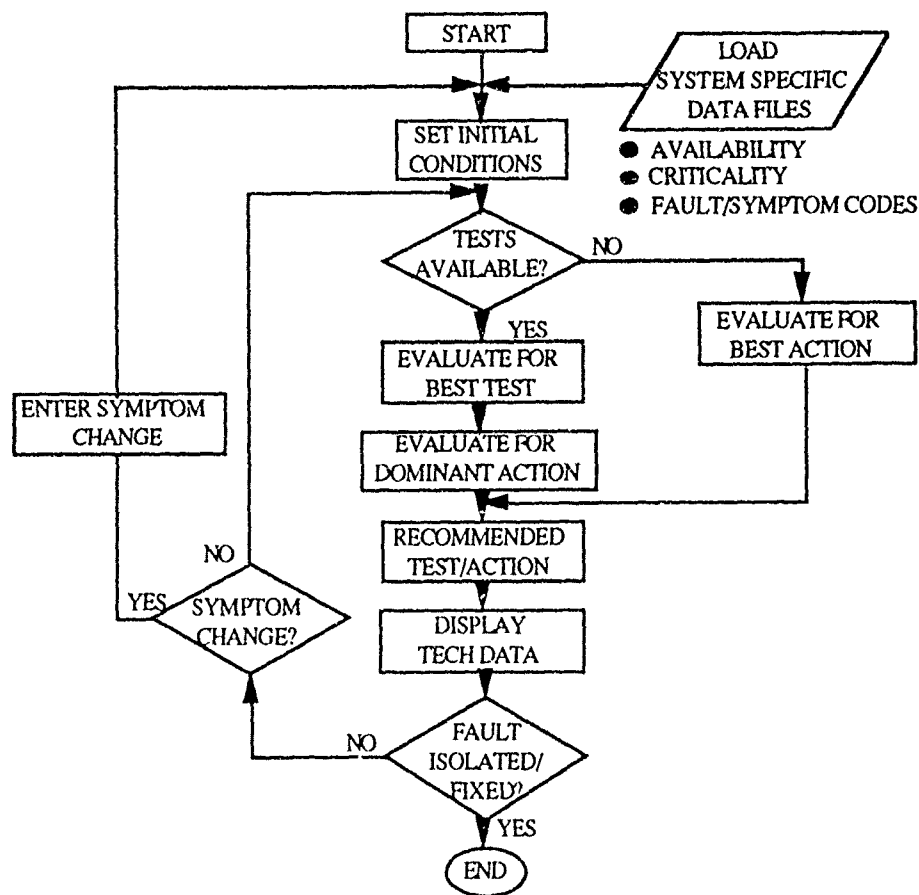
A troubleshooting session begins by initializing the fault/symptom data through manual or automatic data entry of all available information such as BIT results, pilot-observed failures, and/or through system health information downloaded from the MIL-STD 1553 data bus (see Figure 2, Logic Flow). During this initialization process, equipment and parts availability (updated from a link to the supply computer) can be entered, as well as aircraft configuration (e.g., model type and set-up, such as nuclear or conventional) and critical fault information the IMIS-DM will use in troubleshooting. Knowing the availability of equipment and parts enables the IMIS-DM to mark each action requiring the unavailable items. These actions will not be recommended by the IMIS-DM. Criticality is a term used to designate some system functions essential for operational requirements. All potential faults contained in the critical components are identified as critical. The IMIS-DM searches for plausible faults (implicated by symptoms) identified as critical. This set is then given special consideration in developing recommended actions.

Figure 2. IMIS-DM Logic Flow

With this information, evaluations for best tests and rectifications can be determined. As the maintenance technician performs test and repair actions, faults will be placed into various categories. The category depends on the result of the test or a functional check conducted after the repair action. The fault categories consist of the following: (a) the Union set, containing all possible faults for all noted symptoms; (b) the Plausible set, containing faults currently under examination; (c) the Exculpated set, containing faults proven good by a passed test; (d) the Maybe set, containing faults in combination with exculpated faults provided they are not part of another fault combination still in the Plausible set; and (e) the Rectified set, containing faults associated with the repair action (all the faults that could possibly be fixed by performing that particular action).

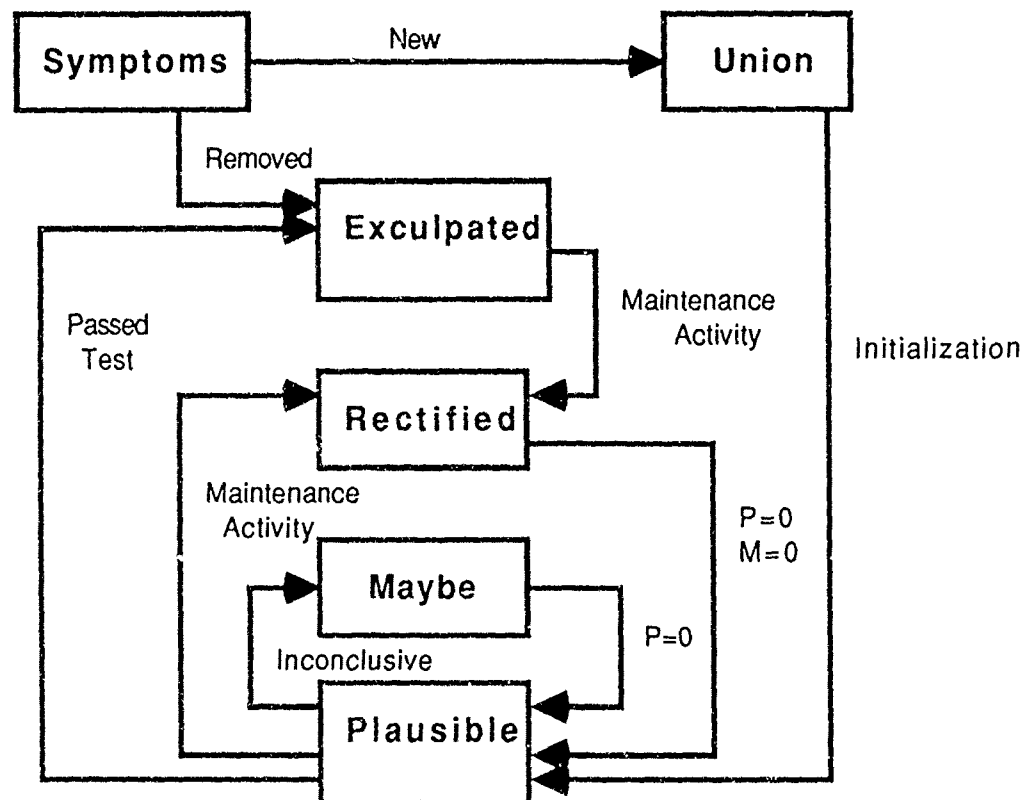
A graphical representation of each possible fault changing during the diagnostic process is shown in Figure 3. The Plausible set is formed after initialization. The technician can proceed with the actions the IMIS-DM has recommended, or an action of his/her own choice. The objective of the diagnostic algorithm is to exculpate all the faults in the plausible set and return no symptoms. If a test is performed and the outcome of that test is a pass, the potential fault(s) will be placed in the Exculpated set. If the outcome is a fail, the potential fault(s) will remain in the Plausible set. Whether the test passes or fails, the IMIS-DM will use the outcome information to update the fault/symptom relationships. If a repair action is completed, a functional check will be performed to verify that the repair has removed the suspected fault(s). If the functional check

passes, the fault will be placed in the Rectified set. A failure of the functional check will update the fault/symptom relationships and keep the fault(s) in the Plausible set. A fault that is in combination with an exculpated fault is placed in the Maybe set. When the Plausible set becomes empty and the failure has not been resolved, plausible faults from the Maybe and Rectified sets will be brought back into the Plausible set to continue diagnostics until the actual fault(s) is found.

Figure 3. Fault Representation Movement.

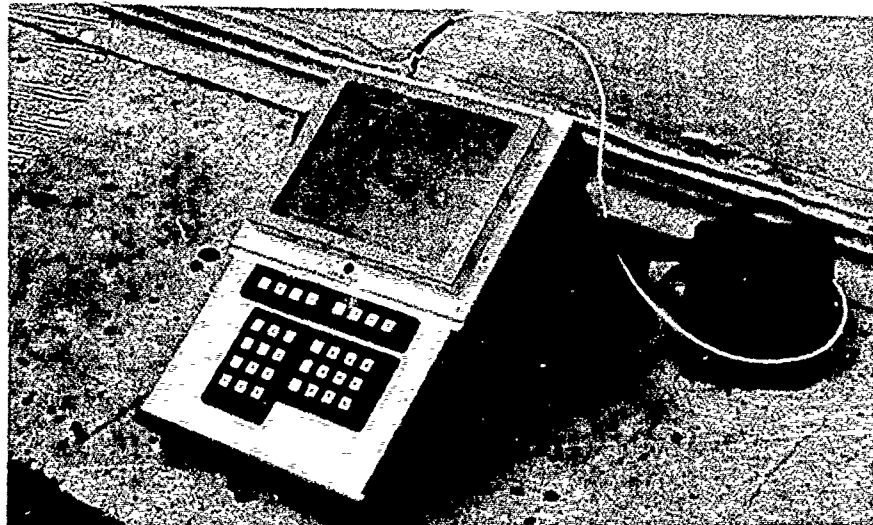
from an AFHRL design based on the Motorola 68020 microprocessor. It has up to 7 megabytes of memory (4 megabytes of internal memory and 3 megabytes from a non-volatile removable cartridge). The operating system is OS-9, a single-user ROM version of UNIX, which offers the functional requirements needed without the software overhead costs of the full implementation of multiuser UNIX. Power requirements were greatly reduced by using a Liquid Crystal Display (LCD) active matrix screen instead of an electroluminescent display. The LCD active matrix screen gives high resolution (81 dots per inch) at one-tenth the power requirements of the PCMAS I screen. Further power reductions come from the use of Complementary Metal Oxide Semiconductor (CMOS) circuitry. In addition, the LCD display is readable under all lighting conditions as it is equipped with a backlight that the user can switch on as needed.

Figure 4. PMA used for IMIS Diagnostics Demonstration.

To reduce the number and size of the circuit boards inside the unit, surface mount technology was used in about 65% of the circuitry. Integrated circuit chips commonly come in a dual in-line package requiring mounting through both sides of a printed circuit board. The smaller surface mount chips require mounting on one side only, leaving the second side available for additional computer chip logic.

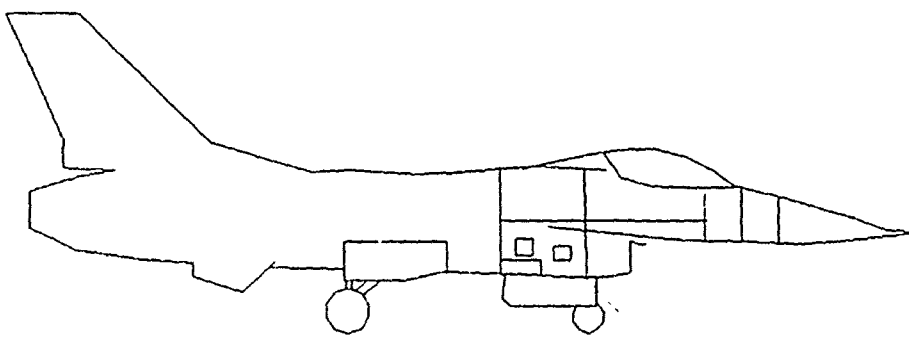
Screen 10 - The expert track for this step shows only the general location of door 2308.

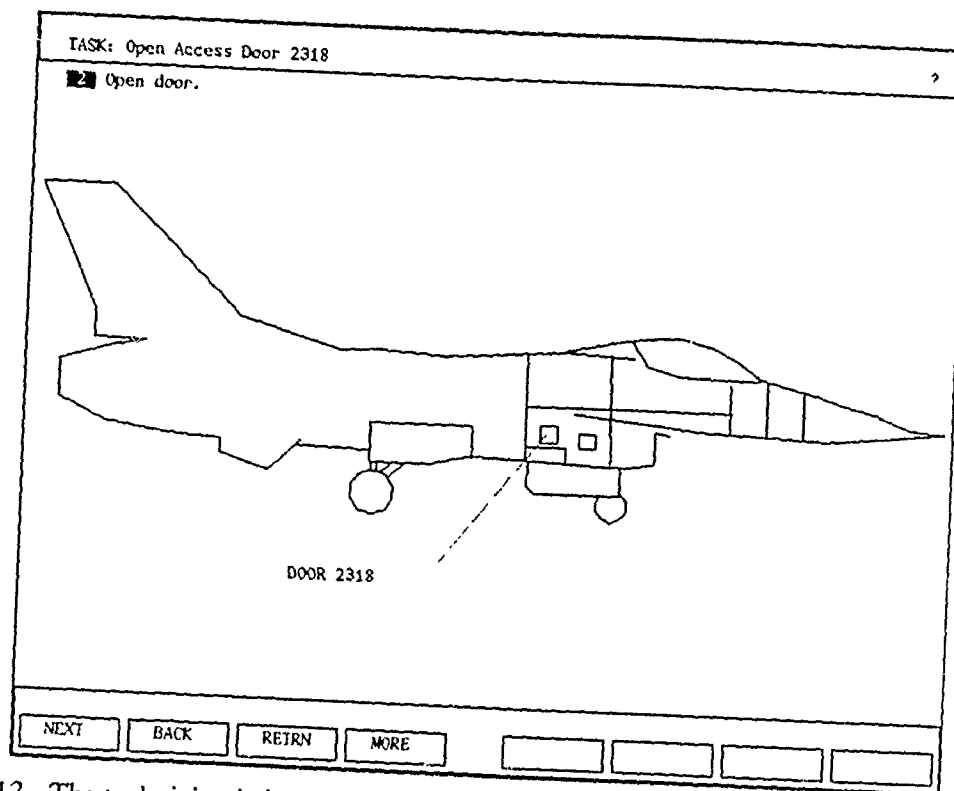
Screen 13 - The technician is instructed to open door 2318 in order to attach the generator set power umbilical.

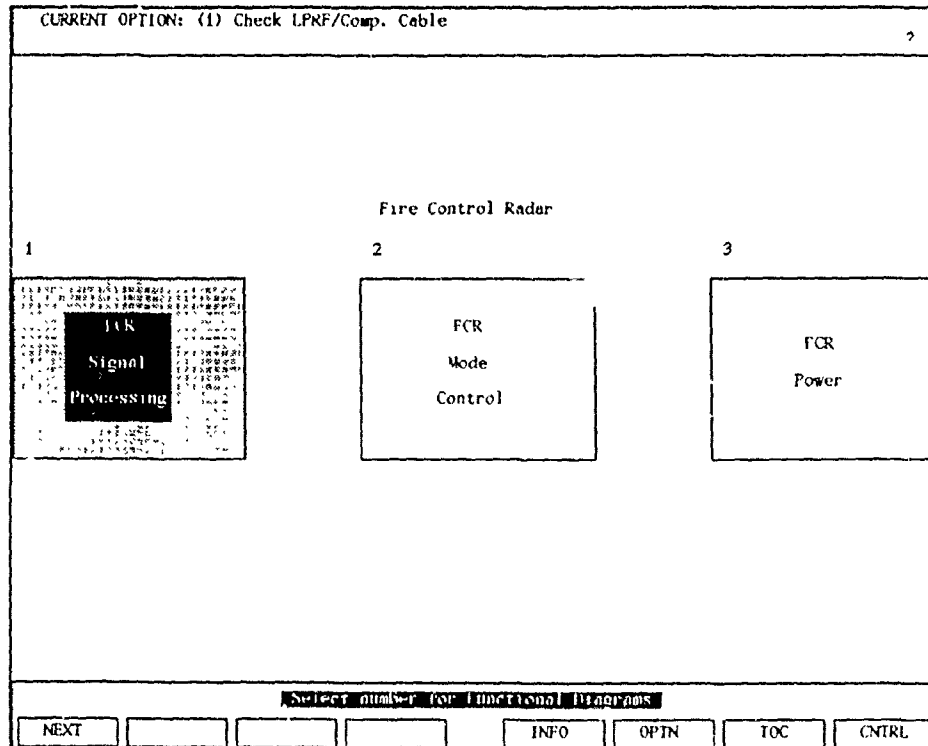
Screen 25 - If the technician selects "0," the first functional diagram is created and displayed for him or her. This diagram indicates that the Current Option (top of screen) is to "Check LPRF/Comp Cables". From the shading of the block diagram, you can see that the operation will be concerned with the FCR Signal Processing portion of the Radar subsystem (black-boxed letters). By pressing 1, 2, or 3, the technician will be presented with a breakdown of the components in the selected area. The selected procedure may be invoked by pressing "NEXT."

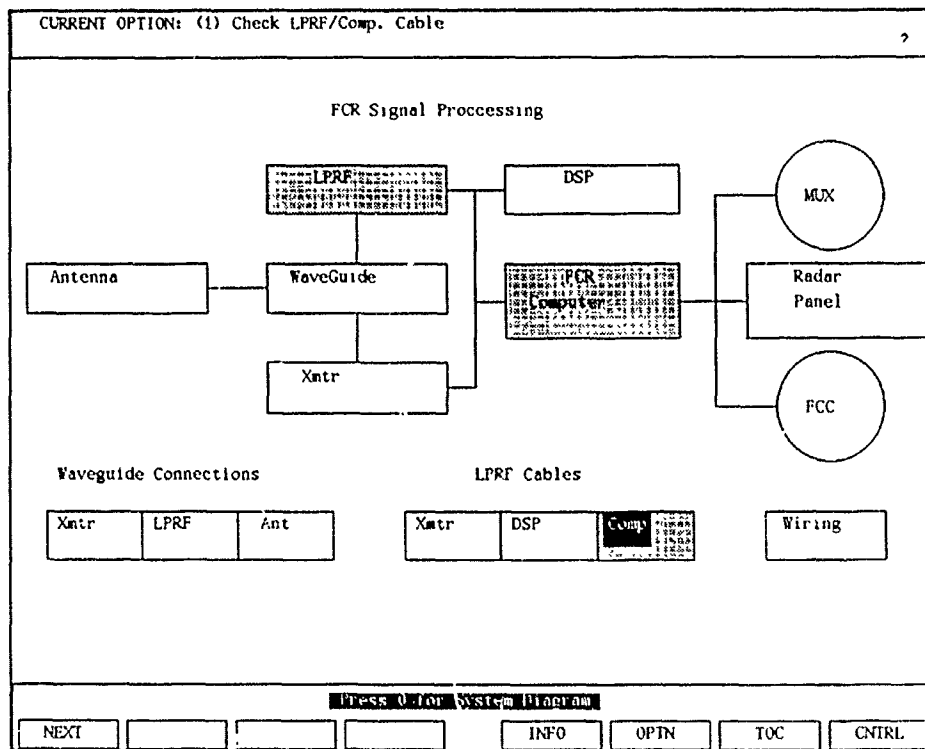
Screen 26 - In this case, the technician wanted to view the block diagram of the signal processing subsystem. This diagram shows the principal LRUs that make up the subsystem (connected with lines), as well as the individual waveguide connections, the LPRF Cables, and the wiring (in isolated boxes). This convention allows an otherwise complex diagram to be shown in a compact manner.

The shading on this diagram indicates that the LPRF, FCR Computer, and the LPRF Cables (Comp) are suspects in the failure and the LPRF Cables (Comp) will be tested by the CURRENT OPTION.

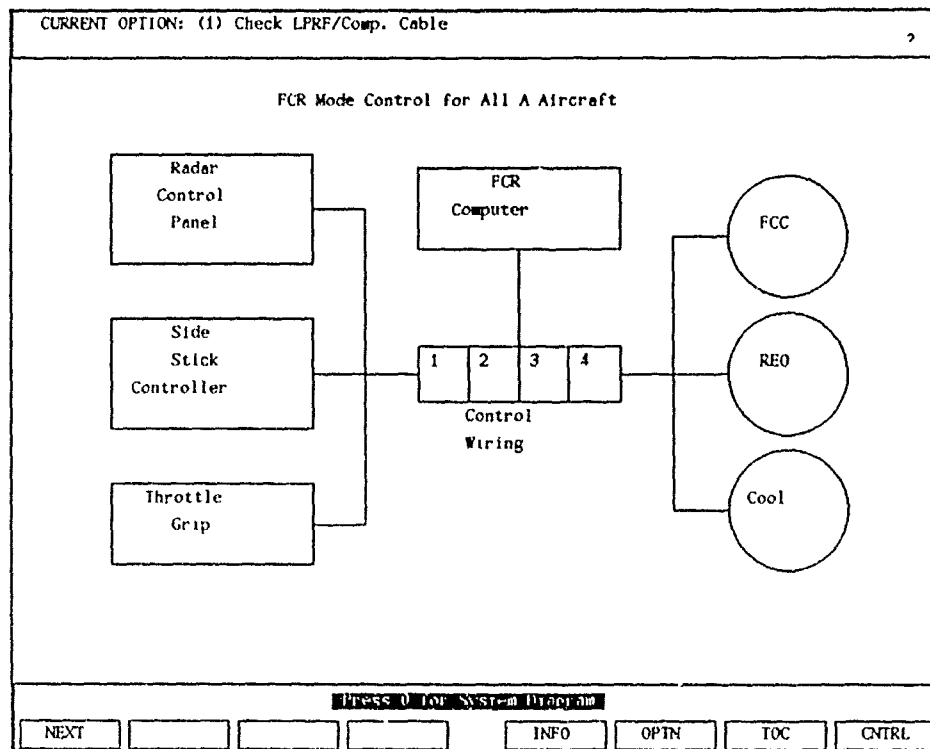
Screen 27 - If the technician wanted to see the block diagram for the FCR mode control, he or she would have selected #2 instead of #1 in screen 25. This screen is displayed for the FCR Mode Control.

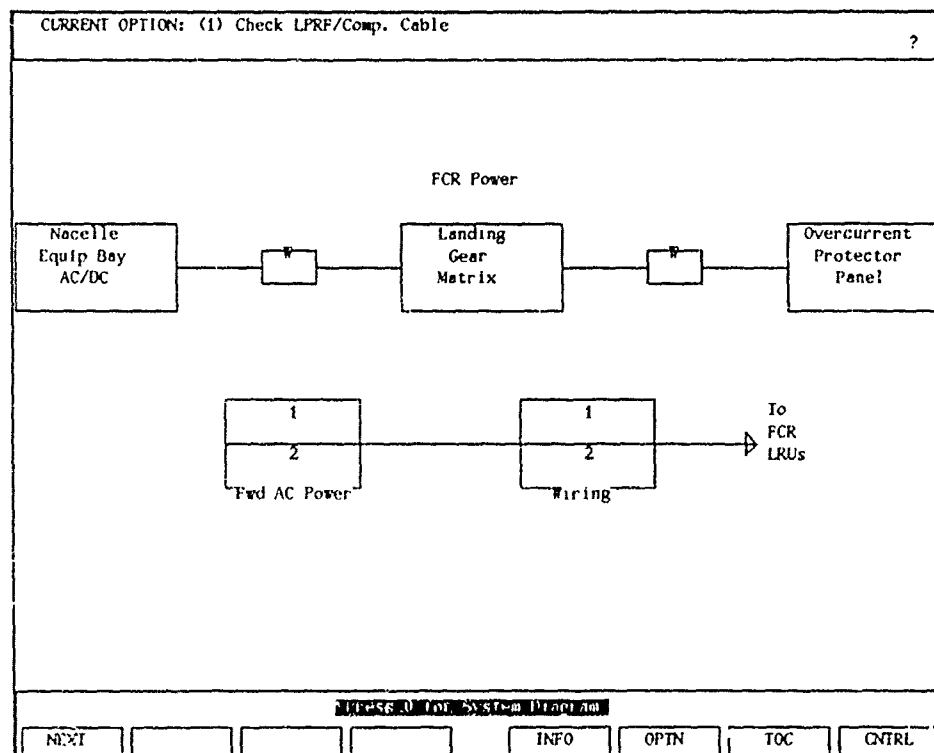
Screen 28 - This is the block diagram for the FCR Power (option #3 in screen 25).

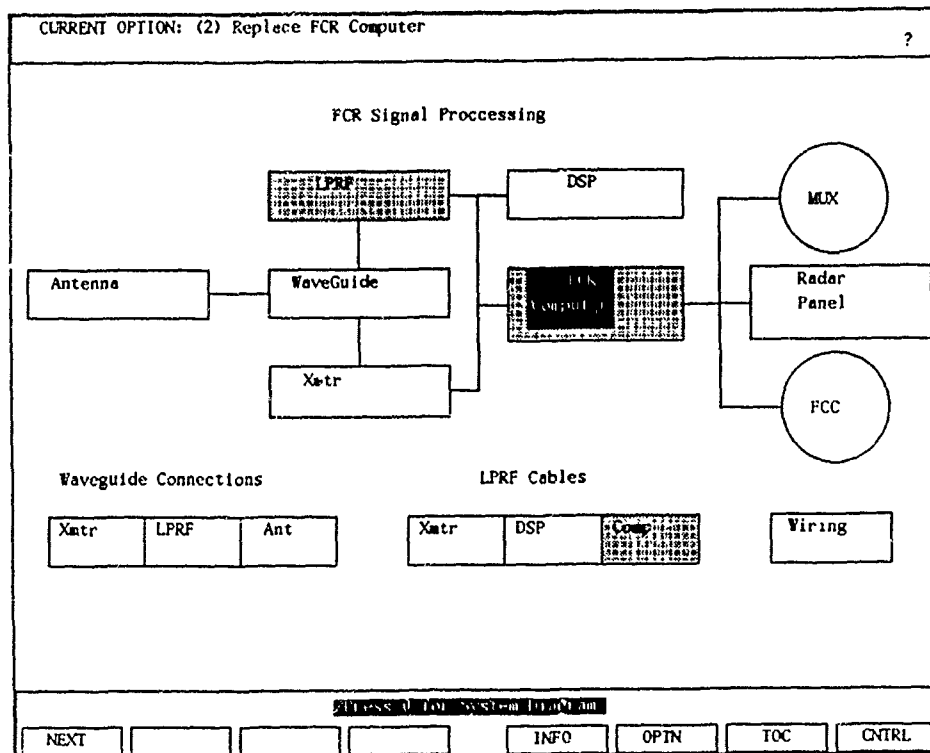
Screen 32 - This screen shows how the components are spanned for the second best option, "Replace FCR Computer" (upper left of the display). The technician may select this option for reasons of his or her own of which MDAS might have no knowledge.

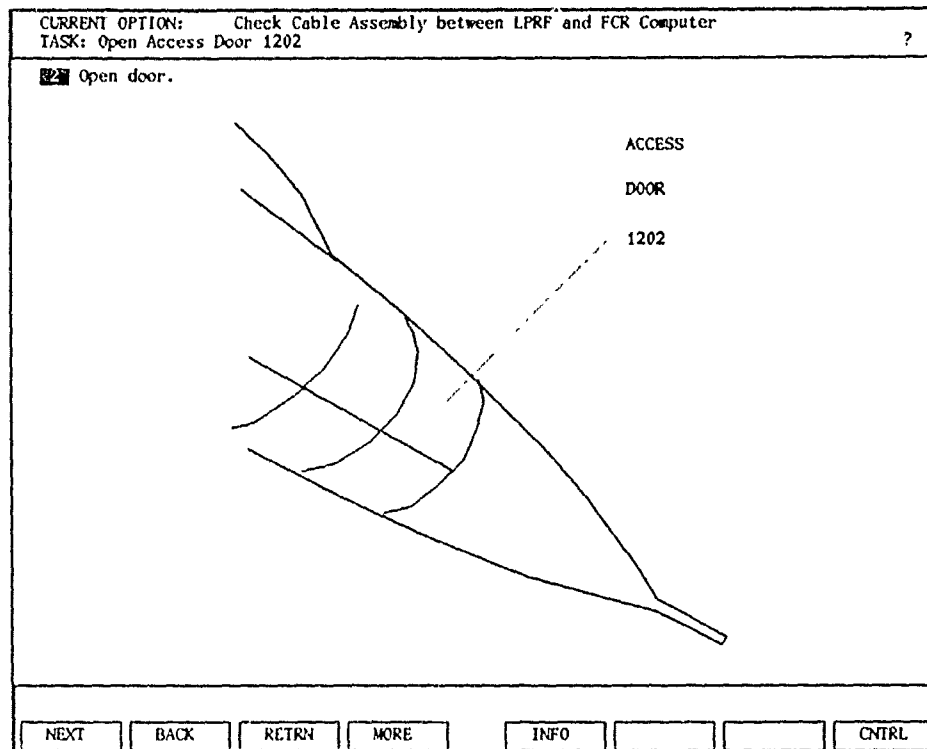
Screen 36 - A graphic to locate the proper door is displayed to the technician. This is the expert track of data for the task. If more detail is desired, the technician can press the "MORE" function key.

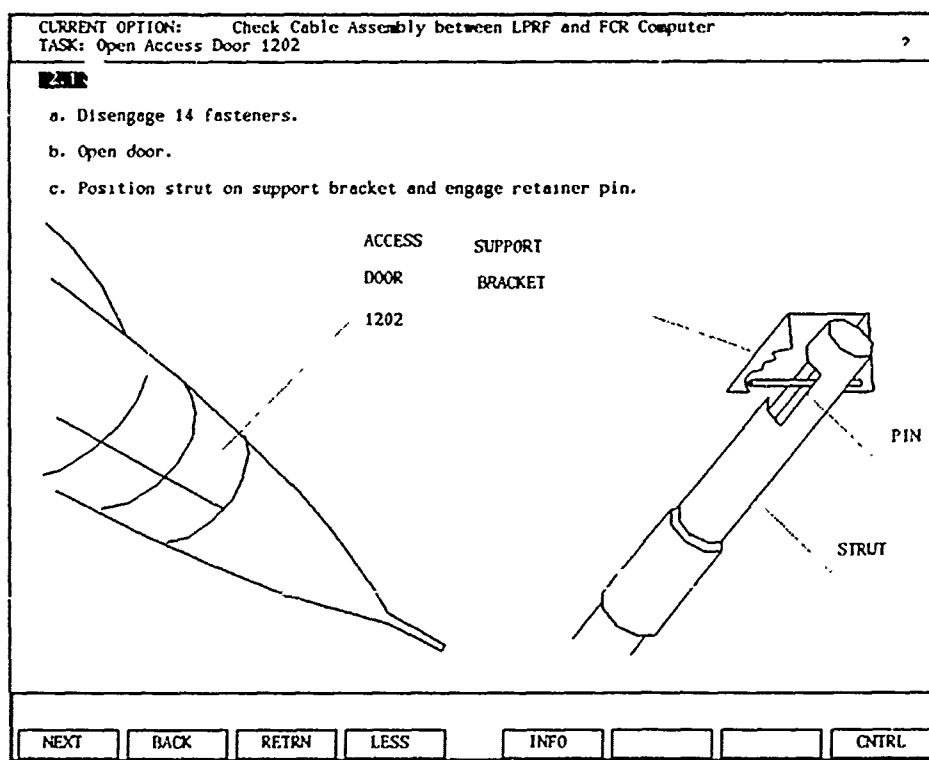
Screen 38 - The novice track displays more detail about the use of the door strut and support bracket.

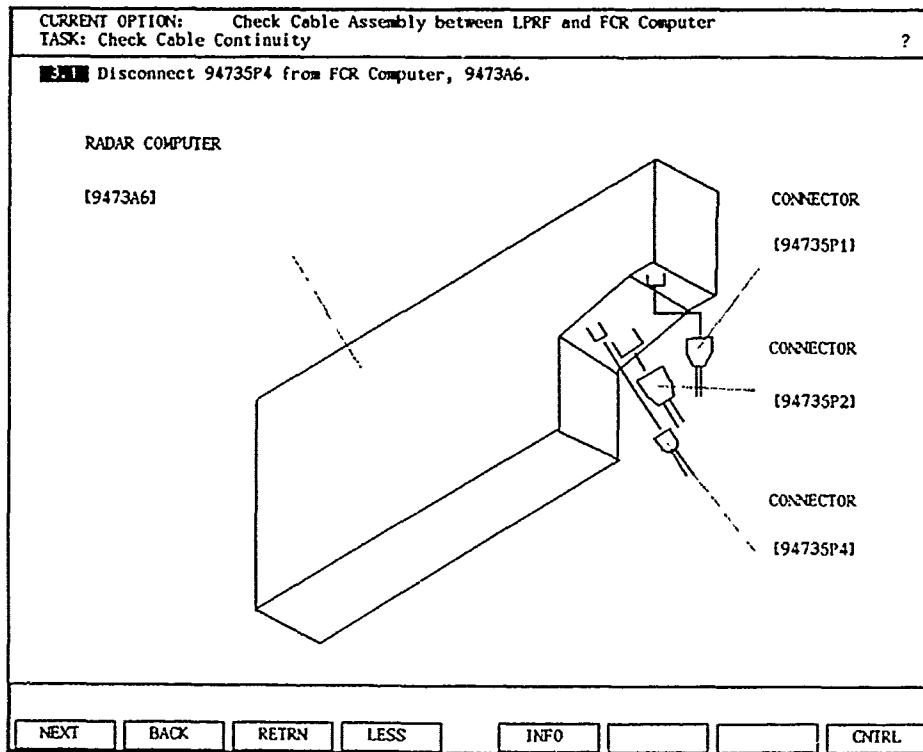
Screen 40 - The novice track of the same task shows a graphic to identify the cables attached to the FCR Computer.

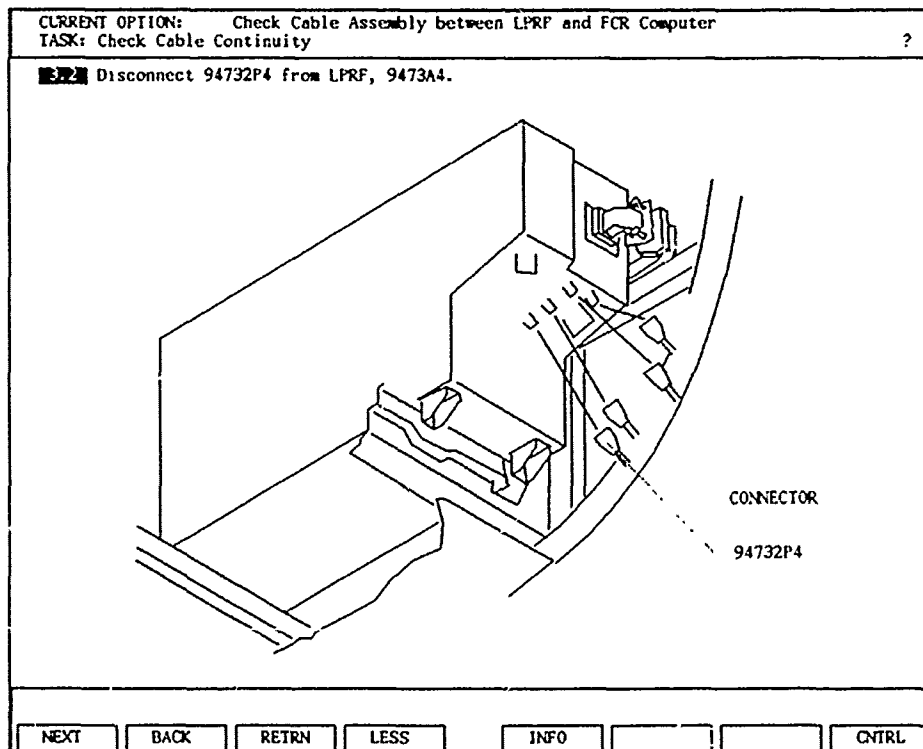
Screen 41 - The novice track then shows a graphic to locate the other end of the cable at the LPRF.

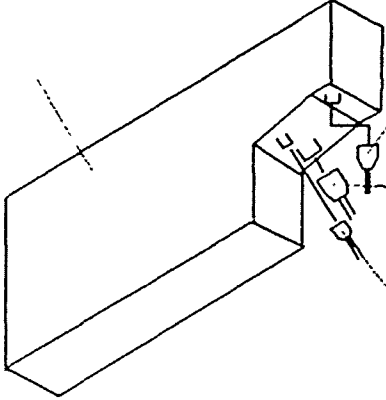
Screen 43 - This novice step makes sure that the pins are not shorted to ground and presents a graphic to help locate the cables. The technician indicates that the cable is not shorted to ground in this scenario by again answering "NO."

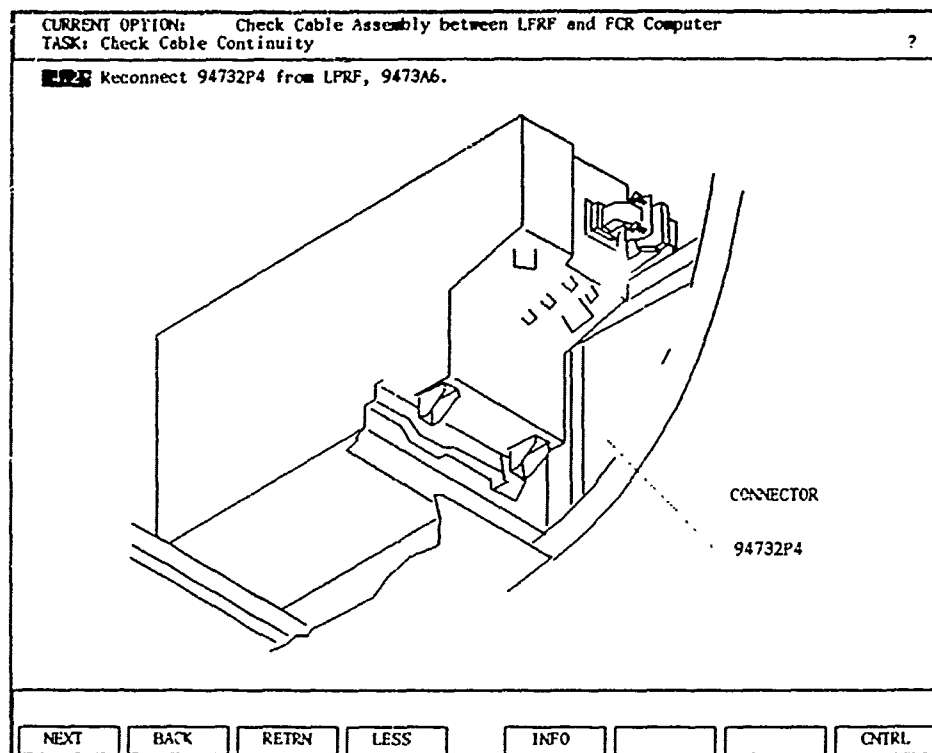
Screen 44 - This novice screen shows the first reassemble step and a supporting graphic.

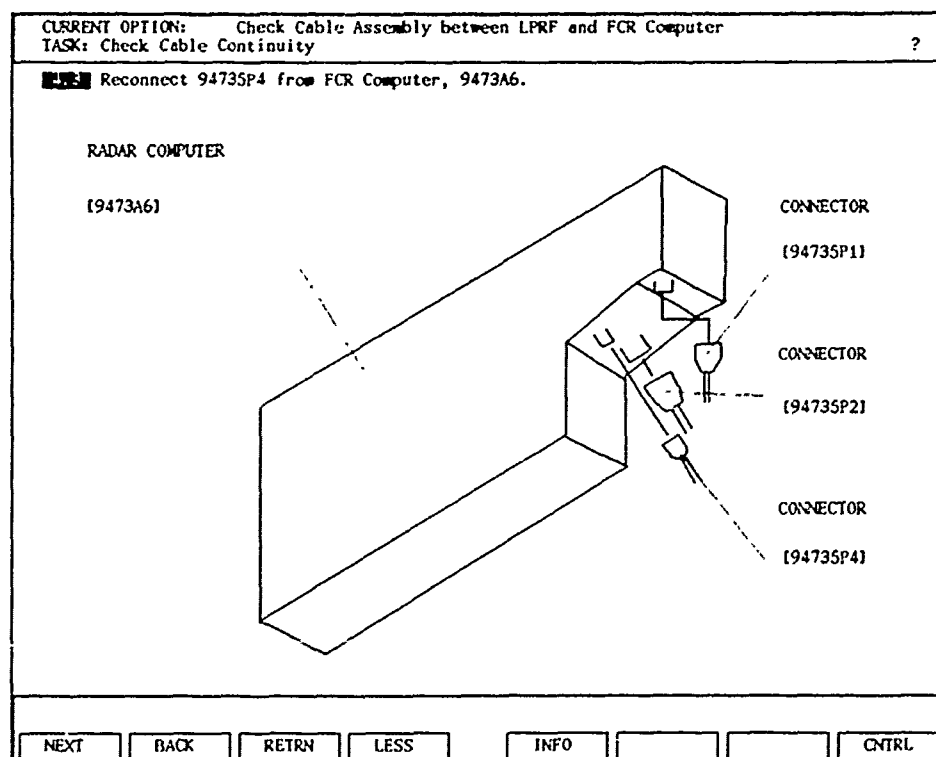
Screen 45 - This novice screen shows how to complete the reassemble procedure.

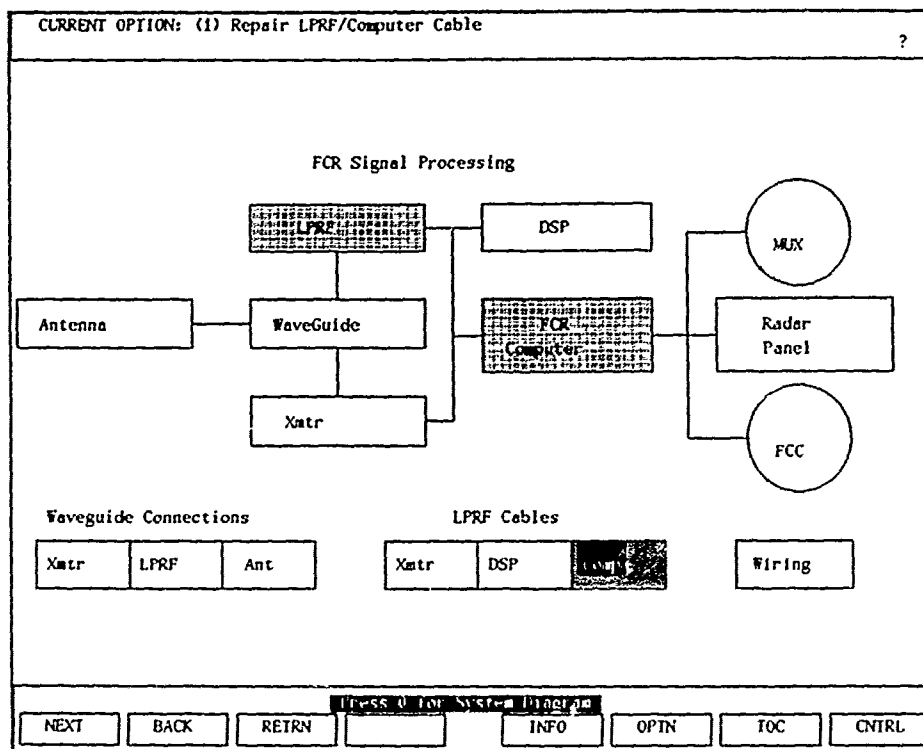
Screen 46 - When the reassembly task is complete, the system graphic is re-displayed. The shading has been changed to indicate that the LPRF and FCR Computer have been downgraded as possible causes of the failure (they are a lighter shade of grey), and are members of the "Maybe" set for diagnostic purposes. This figure also shows that the current option is "Repair LPRF/Computer Cable," which was found to have failed in the last step.

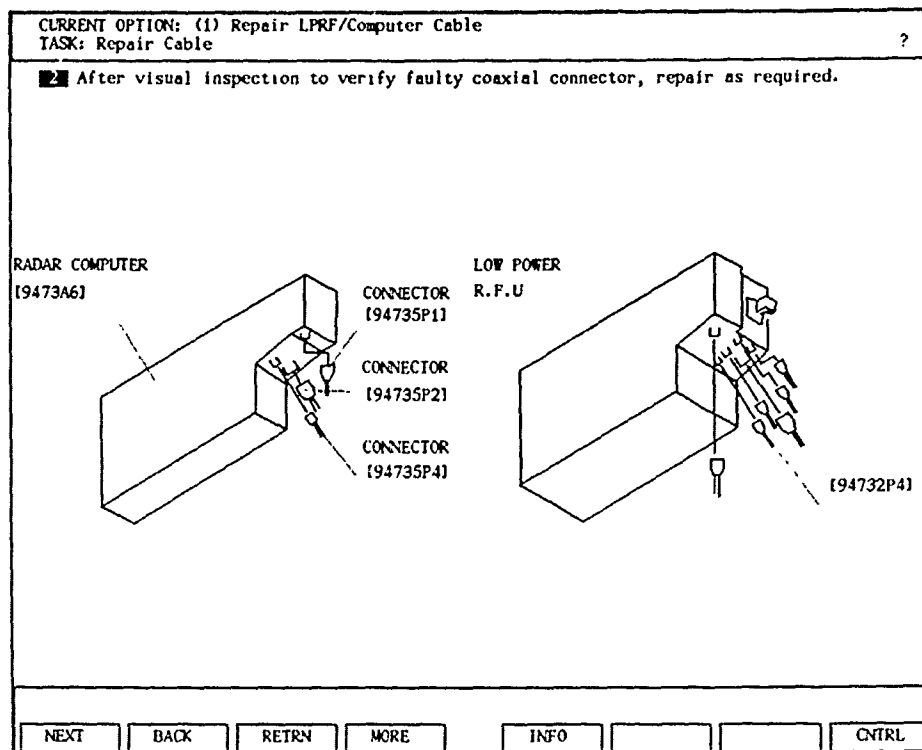
Screen 52 - This screen shows the expert track for the task of repairing the cable. Notice that the "More" function key is available to allow switching to the novice track if needed.

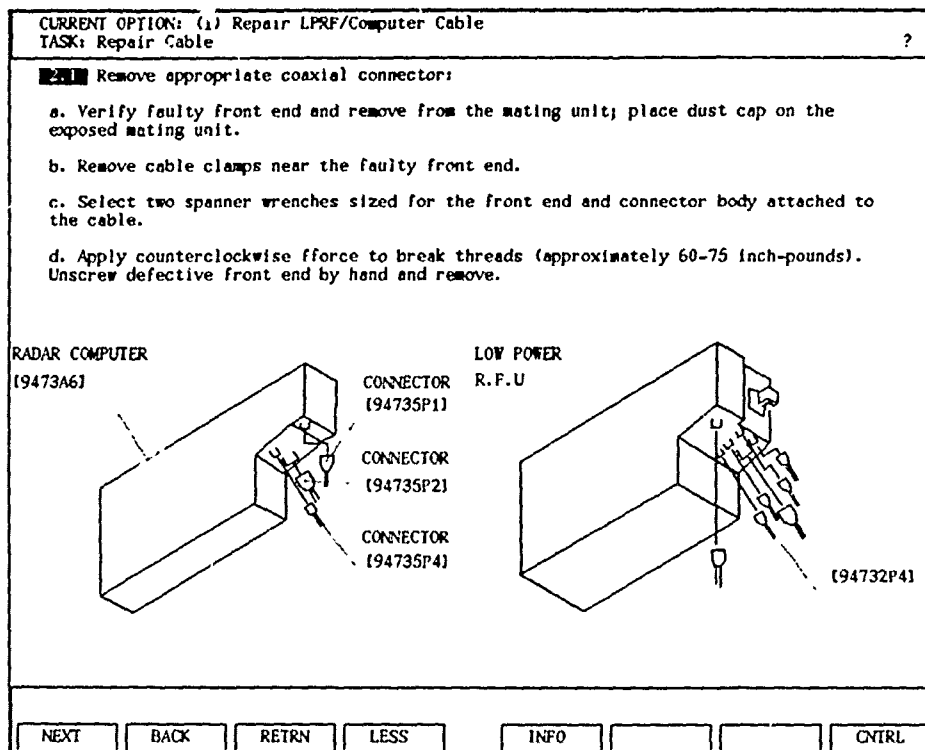
Screen 53 - The "More" function key has been pressed and the details of the cable repair in the novice track are presented to the technician. Notice that the "More" function key has been replaced by a "Less" key. This allows for switching back to the expert track.

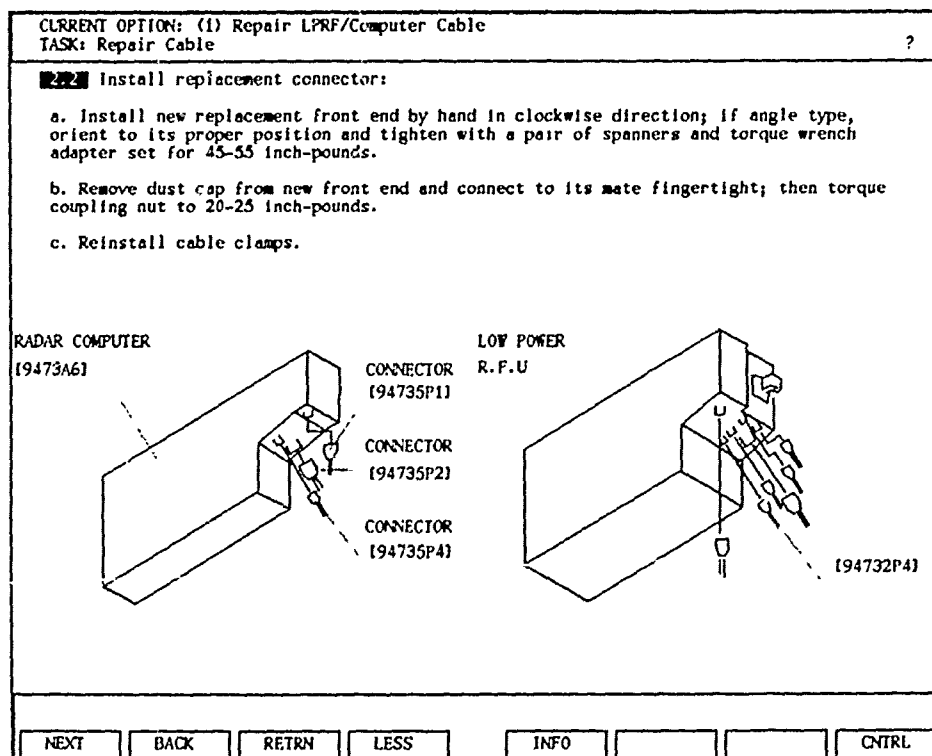
Screen 54 - This is the second screen of instructions at the novice track for the cable repair.

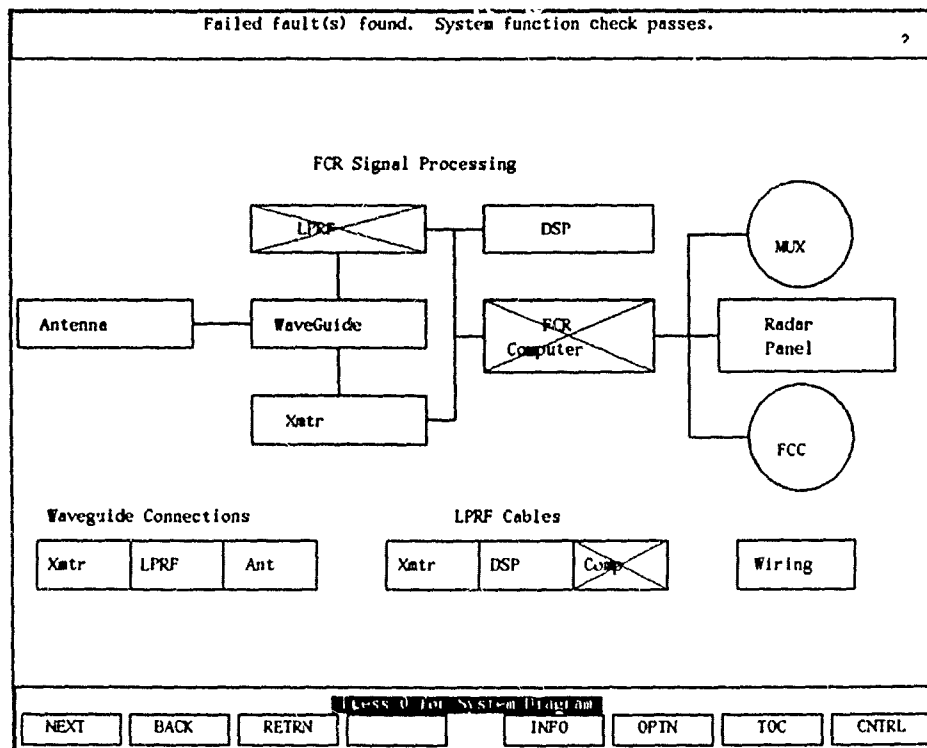
Screen 60 - The system block diagram is again presented, showing that all symptoms have been exculpated and the functional check has passed.
